Nationally Registered Tangible Cultural Property

Gifu Park Three-storied Pagoda

Construction Summary

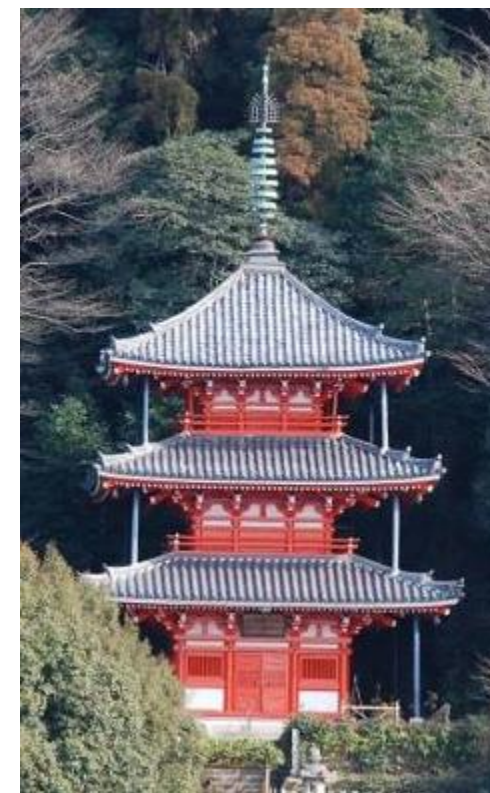
However, as about 100 years have passed since the pagoda was built, its age has become noticeable, showing damage all over. In order to leave the pagoda to future generations for many years to come, it has gone through large-scale restoration for 2 1/2 years between September 2014 and February 2017 to recreate the original image of the pagoda from when it was first built.

Pagoda before restoration (2014)

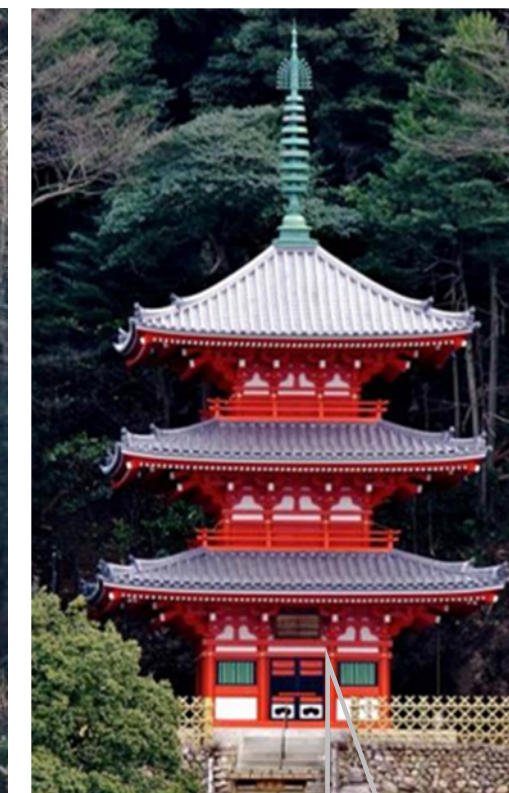
Pagoda after restoration was finished (2017)

This restoration construction work left one part of the main pillar and the first floor level shiten pillars, and dismantled most other parts of the pagoda. The supporting pillars that held up the eaves were removed, as they were disruptive to the scenery.

Also, any places where the wood was rotting or damaged were repaired, weak structural areas were reinforced, and the whole building was reassembled.

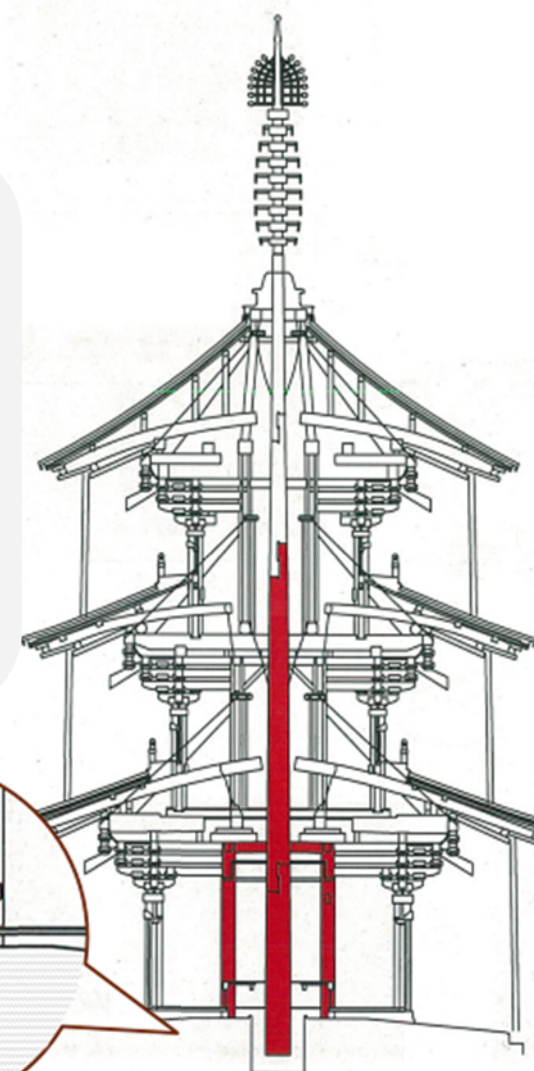
Areas left without dismantling (part of main pillar, first floor shiten pillars: highlighted in red)

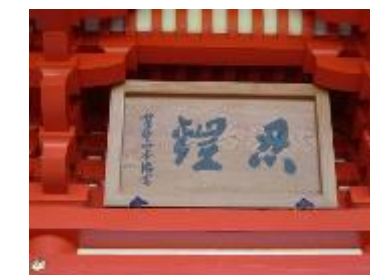
About the frame hung above the main doorway:

Though the surface was weathered and the characters unable to be read, by deepening grooves and raised edges, we were able to restore it to its original design.

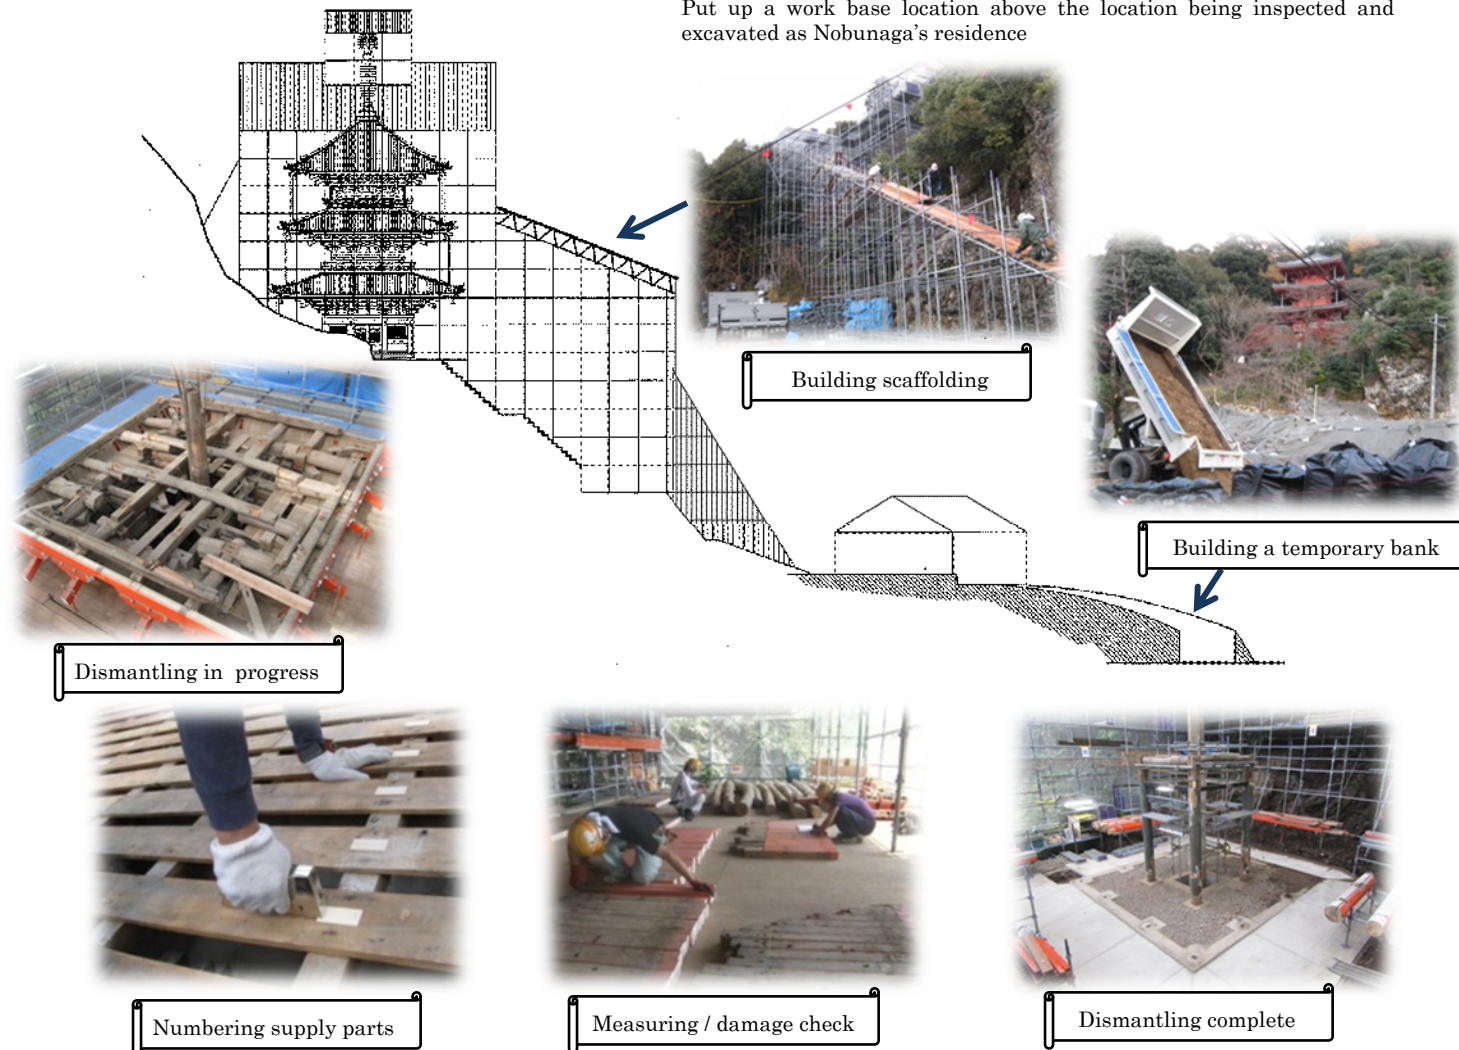
(1) Temporary Construction / Dismantling Inspection

Put up a work base location above the location being inspected and excavated as Nobunaga's residence
